## **E-Krete™ Polymer Composite Micro-Overlay for Airfields: Laboratory Results and Field Demonstrations**

J. Kent Newman and James E. Shoenberger

November 2003

Final report

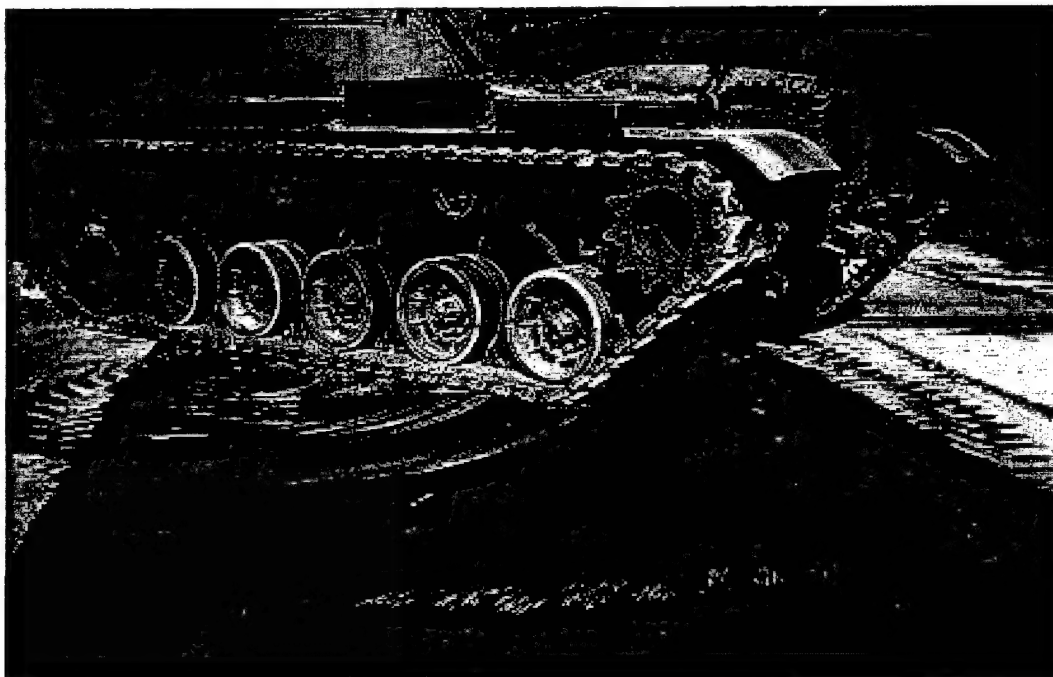
Approximately 10 total pivot steers were conducted on the E-Krete™ surfaces with no delamination from the underlying asphalt. The damage to the E-Krete™ surface was some slight scuffing of the surface in areas with a surface layer of broadcast sand. The sand had sheared loose from the surface and caused scuffing under the tank treads. The areas that had no surface

Figure 3. 106,000-lb M-60 tank conducting pivot steers on E-Krete surface at ERDC

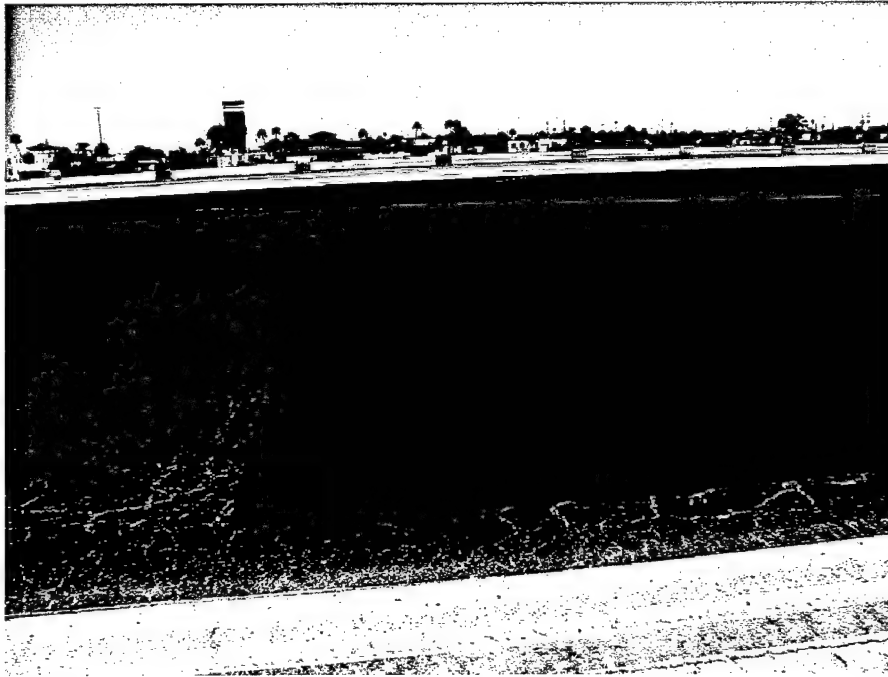
Figure 5. E-Krete surface in October 2000 at MacDill AFB. The adjacent pavement is coal tar that is approximately 14 years old and is severely deteriorated

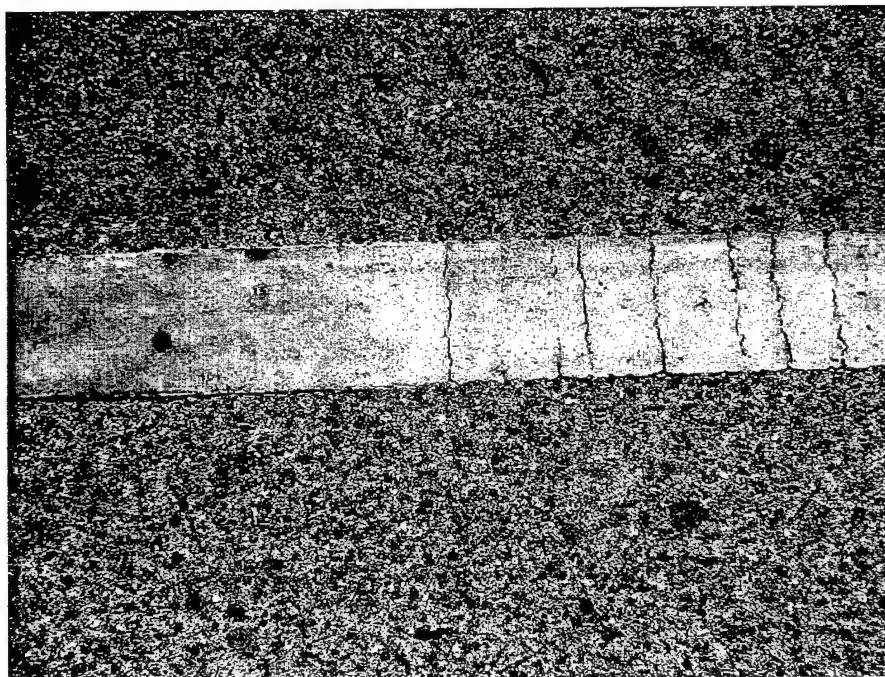
Figure 8. PermaStripe line at MacDill AFB in October 2000 after a full 2 years in service. Note the transverse cracking in the conventional airfield pavement marking paint. The marking paint is approximately 3 years old in this picture

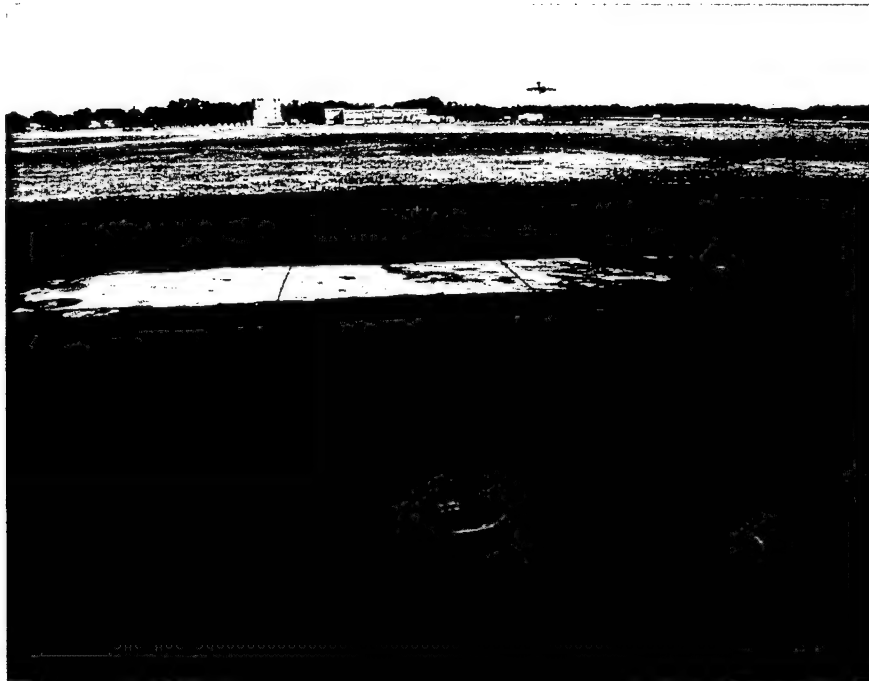
Figure 12. E-Krete and PermaStripe at Norfolk Naval Station. Note the severe hydraulic fluid staining around the concrete island. This area has been used repeatedly for servicing aircraft

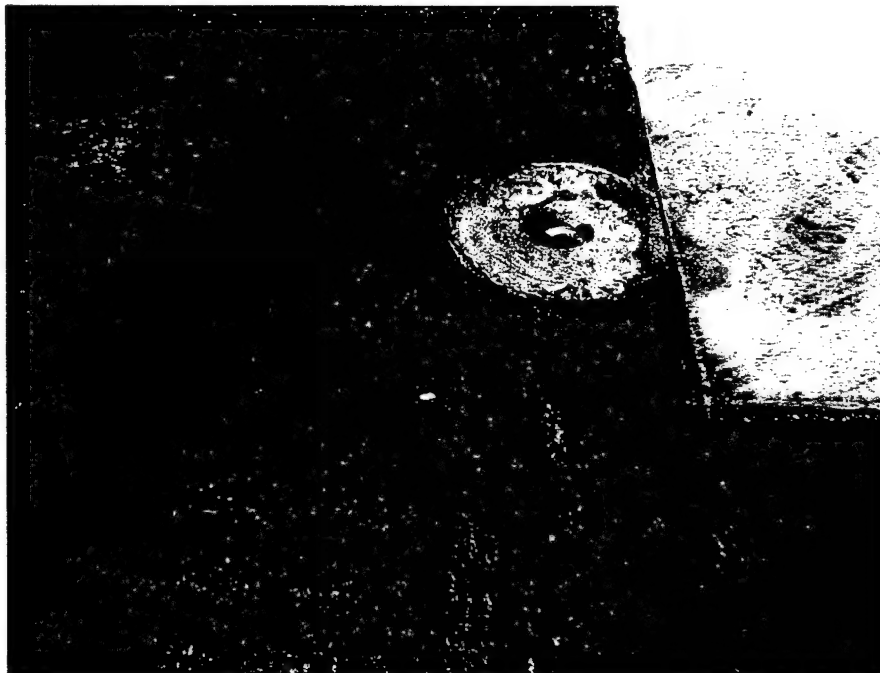
Figure 13. Closeup view of the E-Krete and PermaStripe at Norfolk Naval Station. The hydraulic fluid is literally pooled around the PermaStripe tie-down. Some delamination of the PermaStripe has occurred because of the ingress of hydraulic fluid under the surface of the PermaStripe where the asphalt and concrete meet

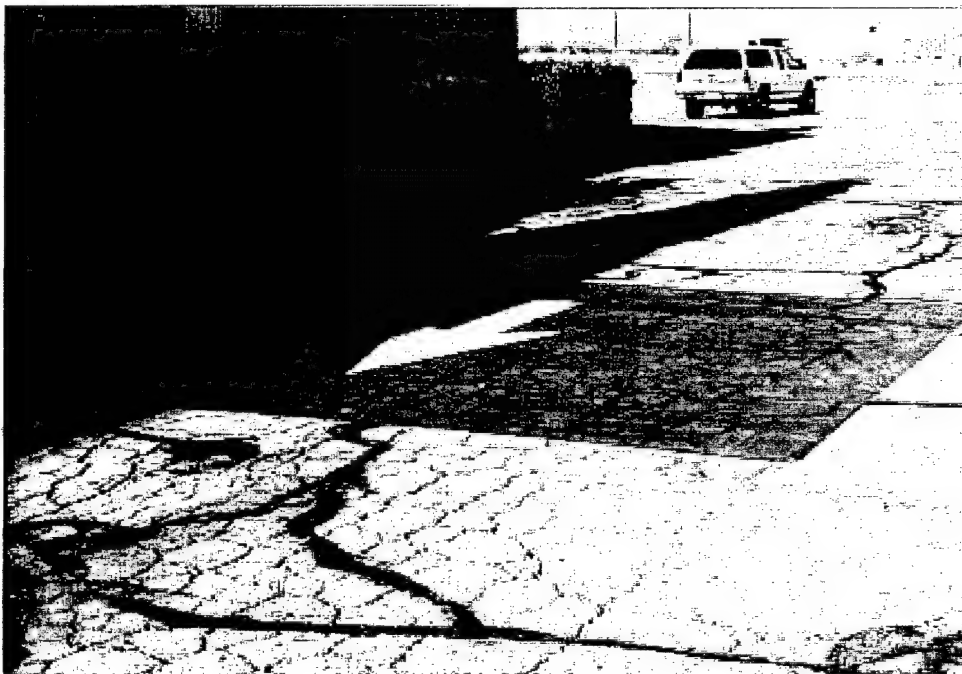
Figure 14. E-Krete and PermaStripe at Edwards AFB. Note the severely cracked asphalt surface upon which the E-Krete was placed. Although many of the cracks have reflected back up through the E-Krete, it is in much better condition than the asphalt with virtually no raveling, unlike the surrounding pavement

The condition of the E-Krete™ was excellent aside from the reflective cracks from the underlying asphalt. The reflective cracking is excessive but no distresses related to the E-Krete™ were noted. Some minor raveling from the crack faces had occurred where there is noticeable unevenness in the substrate and in areas where the underlying asphalt cracks were about ½ in. wide. Some cracks have also reflected through the white arrow. The color of the E-Krete™ is darker than the surrounding pavement and is holding the color well. There is a white arrow of PermaStripe™ in the middle of this section that was placed directly on top of the E-Krete™. This section receives car and light truck traffic only. Frictional resistance was not measured since traffic was present during the inspection. Adhesion tests conducted on the E-Krete™ section pulled up the underlying asphalt.

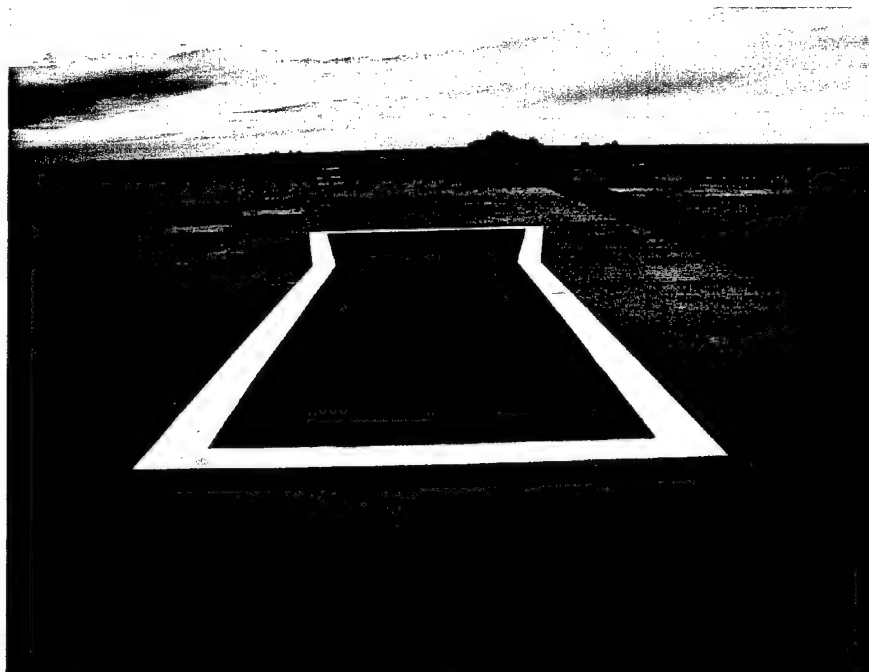
Figure 19. "Red Carpet" area in November 2000. Some fading of the red has occurred and reflective cracks are present, but overall, this section is in excellent condition

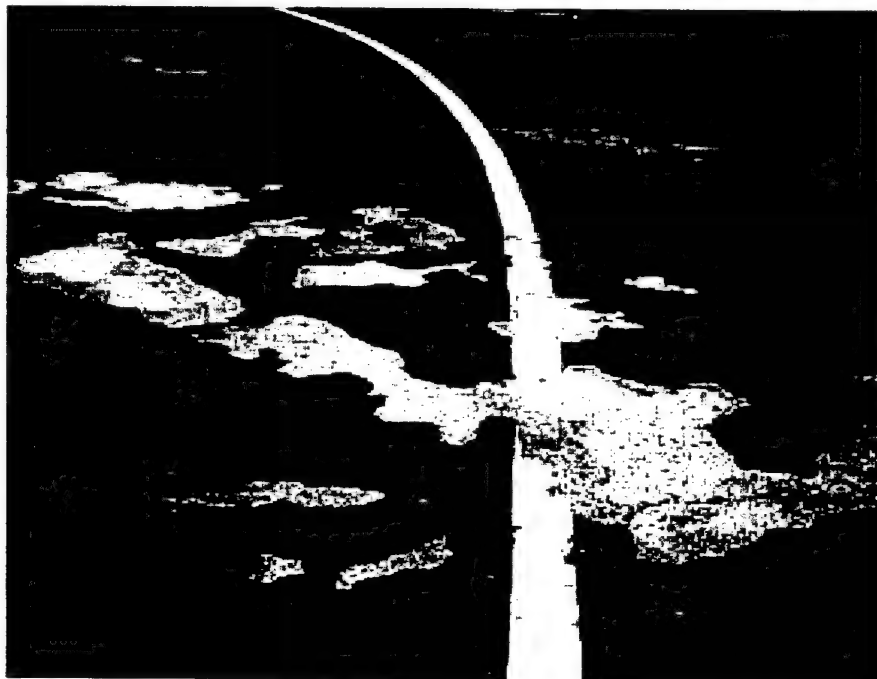
Figure 21. Severe delamination of existing coal tar surface (prior to E-Krete application)

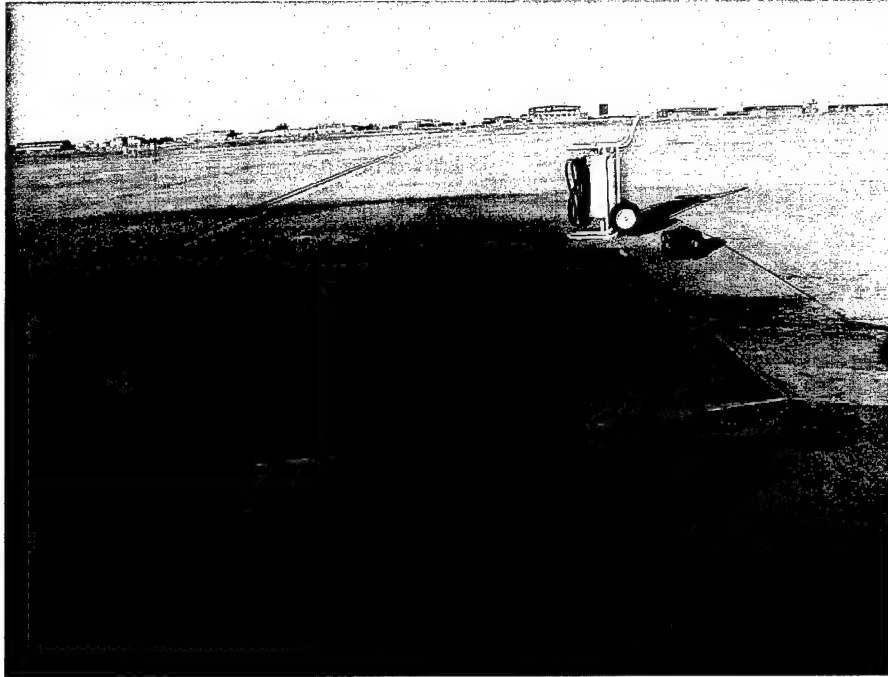
Figure 23. Overall view of B1B aircraft pad B11 in November 2000. The E-Krete is completely soaked with hydraulic and turbine fluid and is in good condition

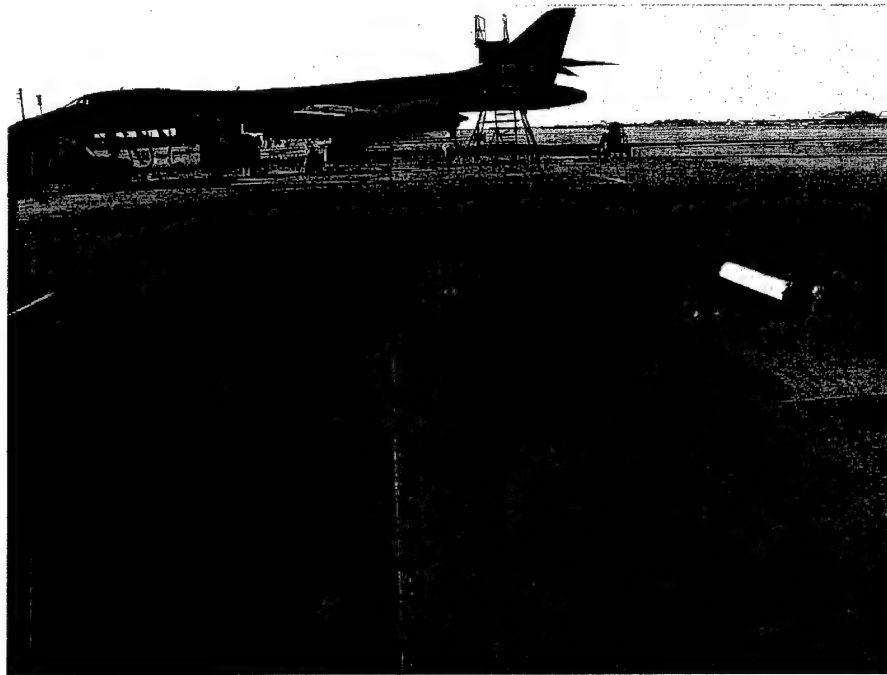
Figure 24. Overall view of B1B aircraft pad B10 in November 2000. As with B11, the E-Krete is completely soaked with aircraft hydraulic and turbine fluid and is in good condition.
